Re: Inaccurate SJM 3219 Safety Alerts & Skyjack Service Bulletins 60 and 77

Service Bulletin #60 SJM3219 Scissor Ends Inspection And Repair

Service Bulletin #77
SJM3219 Scissor Ends Inspection and Repair
*******SAFETY RELATED*******

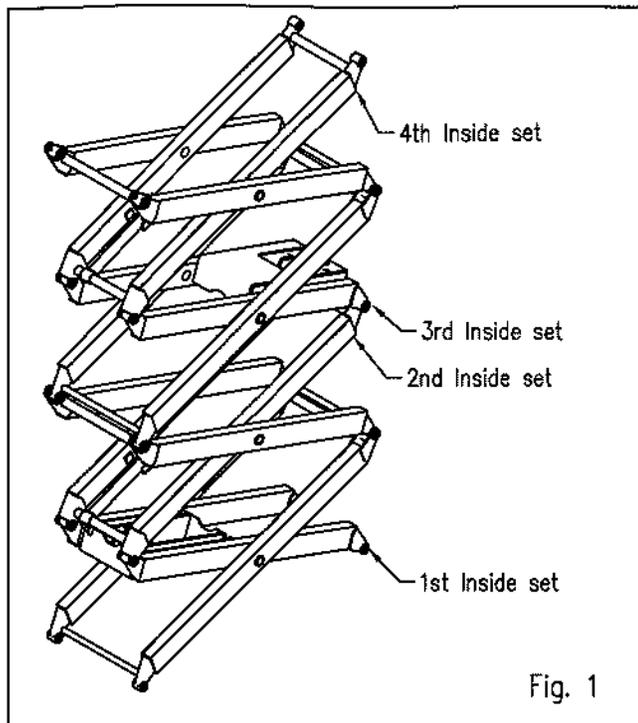
Fig. 1

1. Raise the machine to approximately a platform height of six feet.
2. Set safety bar in place
3. Visually inspect for cracks on all male and female scissor end weldments. Special attention should be focused on the second and third inner level scissor end weldments, both ends and the tubes up to approximately one-inch from the weld. (Note: Level #1 is the bottom level)

Note:
From Machines inspected, cracks
have shown in 2nd and 3rd inner
scissor arm sets.

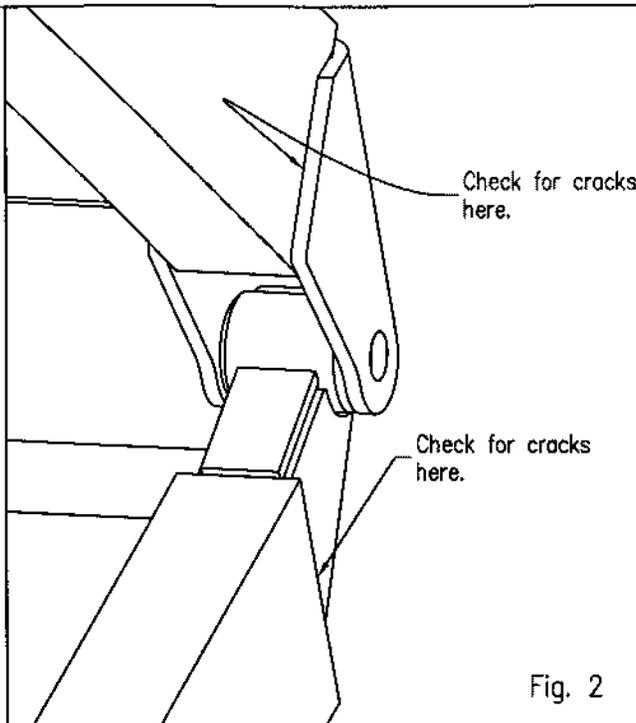
Fig. 2

1. Completely lower the machine.
2. Connect pressure gauge to the lift hose and set lift pressure to the pressure stated on the unit's identification plate.
3. Ensure unit lifts 500 lbs. And no more.
4. Cycle the unit to ensure smooth operation and re-inspect scissor ends for any cracking.
(See Figures #1 & #2)

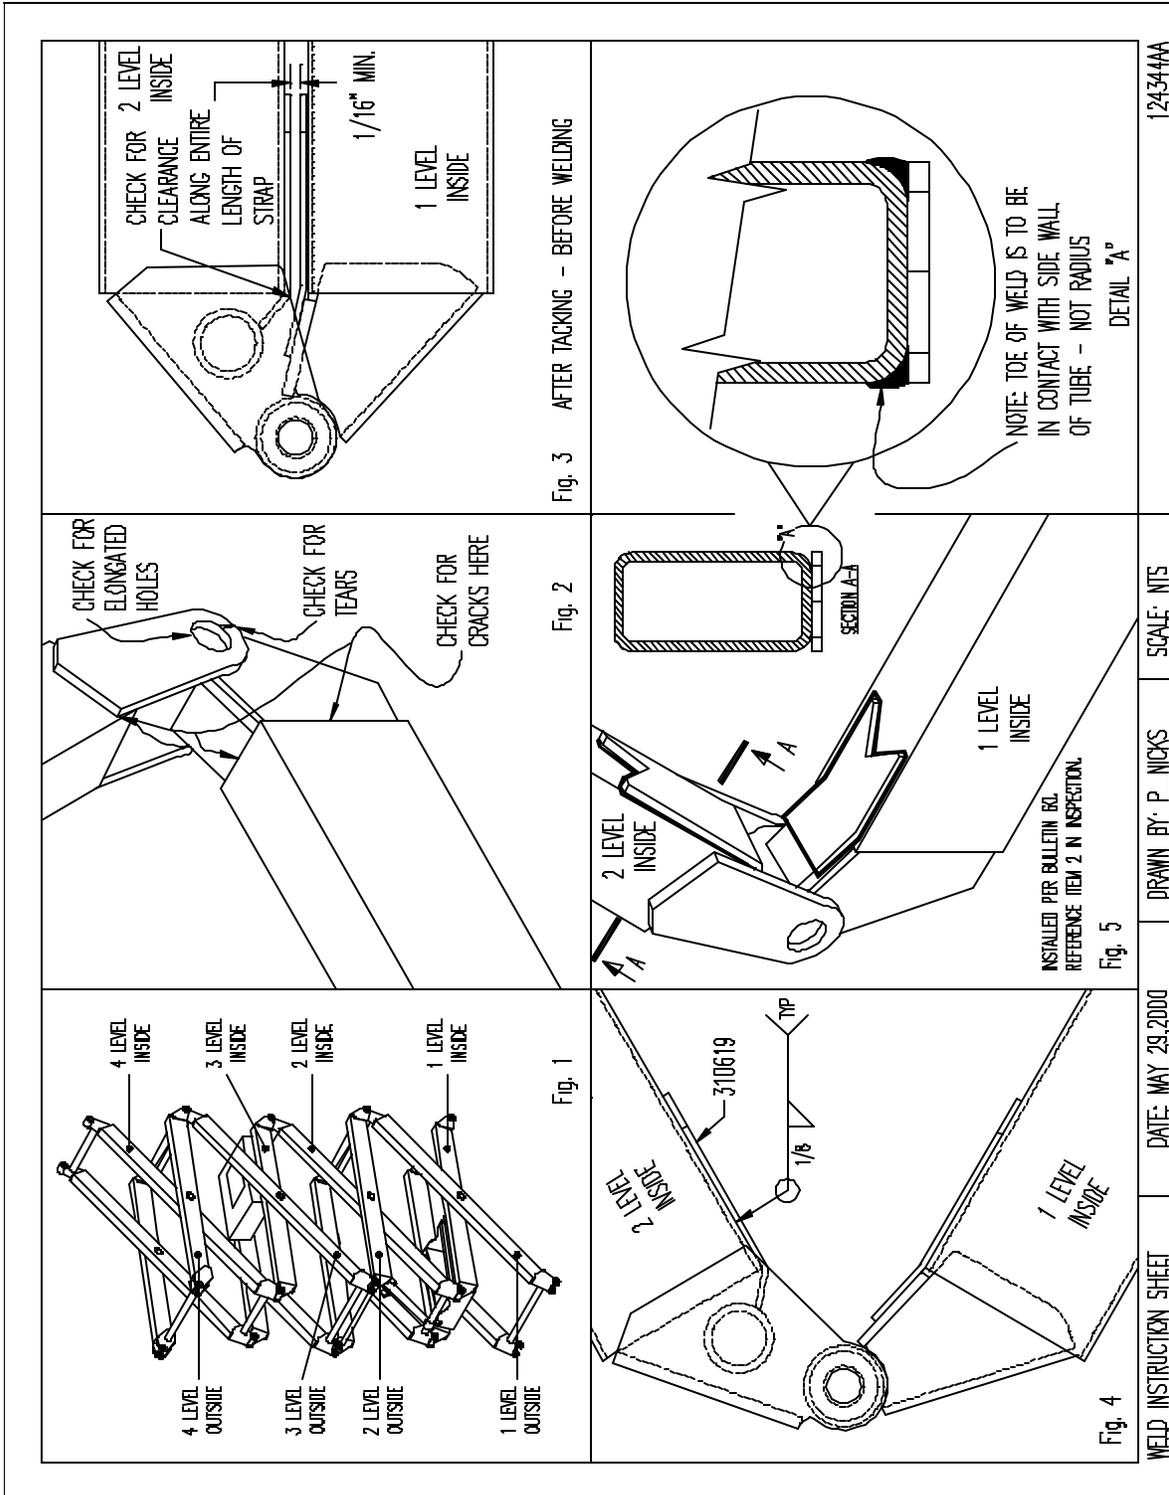
WELD INSTRUCTION SHEET

1. Check for elongated holes or torn scissor end ears on female scissor ends, particularly on the one on inside level 2. A scissor end hole is to be considered elongated when a 0.032" feeler wire fits into the gap between the pin and the hole edge at the widest part of the gap.
2. Check if some scissor ends have reinforcing straps. This bulletin is for the installation of reinforcing straps on the female scissor ends as per item 5, page 3. If no scissor ends have reinforcing straps, please complete Service Bulletin #60 before proceeding with work described in this service bulletin. If you need a copy of Service Bulletin #60, contact SKYJACK service at 800-275-9522 or 630-262-0005.

3. After paint removal, visually inspect for cracks and faulty welds on all male and female scissor end weldments. Special attention shall be focused on the bottom corners of the scissor tube at the toe of the welds joining the female scissor ends to the tube. See Fig. #2.

4. Remove paint from the area of cracks to be welded and weld the cracks.
5. Remove paint from the areas where the provided reinforcing straps, part #310619, are to be welded (see figures #3 and 4). Note: All female ends are to be reinforced with strap #310619, except the four female ends at the base (bottom of level 1) and the two female ends under the platform (the top of level 4). (Note: Only level 2 inside is shown in figures # 4 and 5).

6. At each location in turn, clamp the provided strap to the scissor tube at the female scissor end making sure that the end of the strap is in contact with the boss inside the female end and the length of the strap is in complete contact along the tube. See figures #3 and 4.

9. Check that there is clearance between each male and female scissor end as shown in figure # 3. Use a feeler strap 1/16" thick. If there is interference or contact between the boss in the female end and the adjacent male end or the strap and the adjacent scissor tube, adjust the strap location. If this is not possible, report to SKYJACK service at 800-275-9522 or 630-262-0005.

10. If there is clearance, raise the platform back to the position required for welding.
11. Weld all straps all around with 1/8" fillet welds using 3/32" or 1/8" type E7018 rods. The welds must be continuous from the tube to the inside of the female end and across the boss inside the female end. See figures #4 and 5.
