Workplace Health and Safety Queensland

SAFETY ALERT**Haulotte elevating work platform failure****Purpose**

The purpose of this safety alert is to highlight risks associated with a failed cast steel linkage on an elevating work platform (EWP).

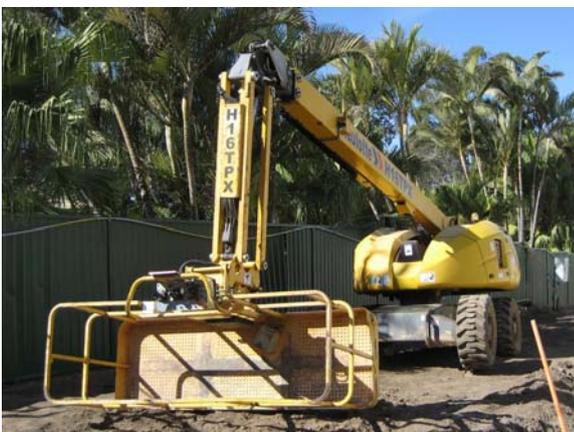
A worker received severe injuries when he was ejected from an EWP on a construction site on the Gold Coast. The incident involved a Haulotte H16TPX boom type EWP, manufactured in 2008.

The linkage between the fly jib and boom catastrophically failed and allowed the platform to drop so that it hung vertically (refer Photograph 1). Photograph 2 shows a close up view of the failed linkage. The linkage on this particular model is manufactured from cast steel.

Photograph 1 – General view of EWP with platform hanging vertically

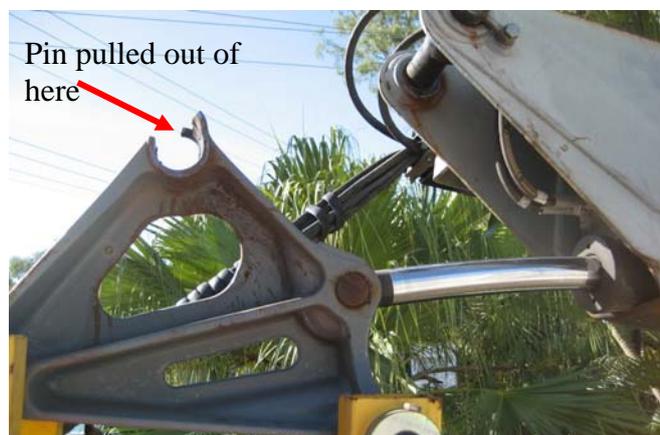
Photograph 2 – Close up of failed linkage

As a matter of urgency, all Haulotte boom type EWPs with a linkage similar to that shown in Photograph 2 are to be inspected by a competent person.

If cracks, excessive wear or other damage are found, then the EWP is to be removed from service. Haulotte Australia Pty Ltd is currently investigating the issue. Owners should seek guidance from the manufacturer on inspection criteria and remedial measures to be taken. Haulotte Australia can be contacted on 1300 207 683.
