Re: Inaccurate SJM 3219 Safety Alerts & Skyjack Service Bulletins 60 and 77

Service Bulletin #60 SJM3219 Scissor Ends Inspection And Repair

Service Bulletin #77
SJM3219 Scissor Ends Inspection and Repair
*******SAFETY RELATED*******

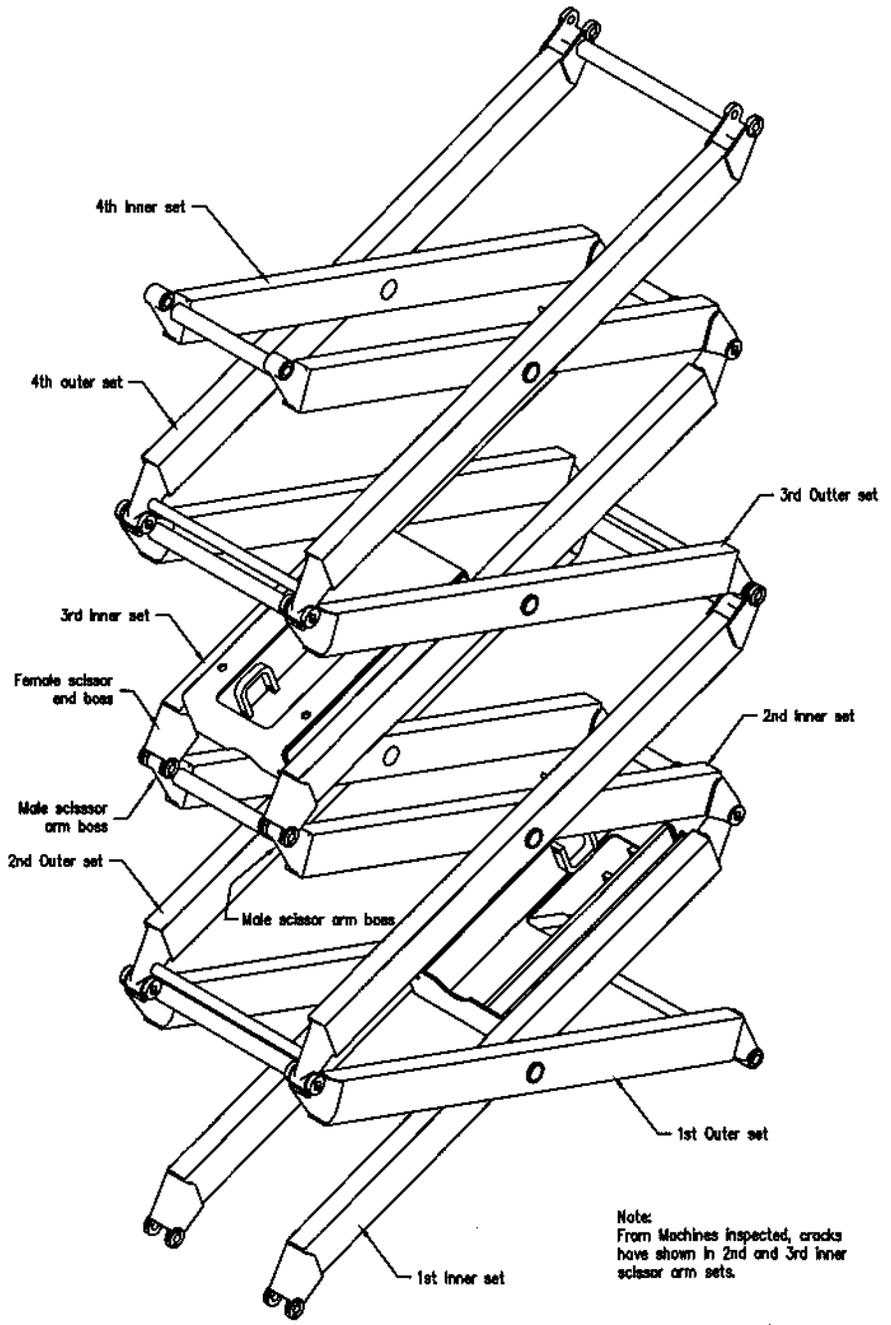
1. Raise the machine to approximately a platform height of six feet.
2. Set safety bar in place
3. Visually inspect for cracks on all male and female scissor end weldments. Special attention should be focused on the second and third inner level scissor end weldments, both ends and the tubes up to approximately one-inch from the weld. (Note: Level #1 is the bottom level)

Note:
From Machines inspected, cracks
have shown in 2nd and 3rd inner
scissor arm sets.
