Workplace Health and Safety Queensland

SAFETY ALERT**Haulotte elevating work platform failure****Purpose**

The purpose of this safety alert is to highlight risks associated with a failed cast steel linkage on an elevating work platform (EWP).

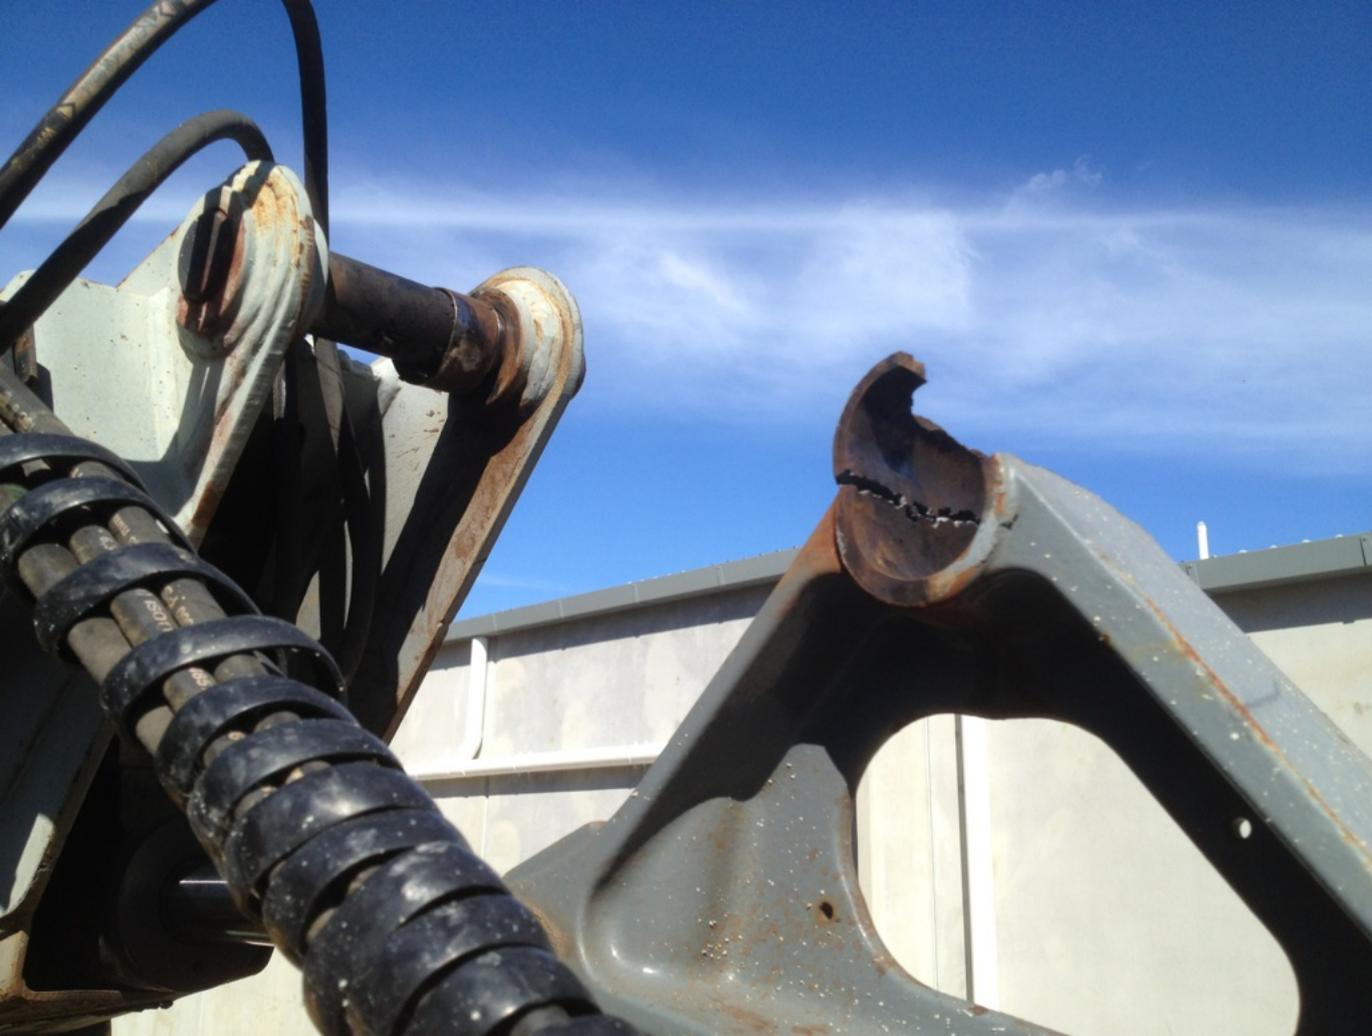
The linkage between the fly jib and boom catastrophically failed and allowed the platform to drop so that it hung vertically (refer Photograph 1). Photograph 2 shows a close up view of the failed linkage. The linkage on this particular model is manufactured from cast steel.

Photograph 2 – Close up of failed linkage

As a matter of urgency, all Haulotte boom type EWPs with a linkage similar to that shown in Photograph 2 are to be inspected by a competent person.

If cracks, excessive wear or other damage are found, then the EWP is to be removed from service. Haulotte Australia Pty Ltd is currently investigating the issue. Owners should seek guidance from the manufacturer on inspection criteria and remedial measures to be taken. Haulotte Australia can be contacted on 1300 207 683.
